National Energy Board

In the Matter of a Public Inquiry
into an Accident at the Liebenthal
Purchase Meter Station on the
Pipeline System Owned and Operated
by TransCanada PipeLines Limited

**Pipeline Accident Report
Order No. MH-2-83**

**TransCanada PipeLines Limited
Industrial Fatality
Liebenthal Purchase Meter Station
28 September 1983**

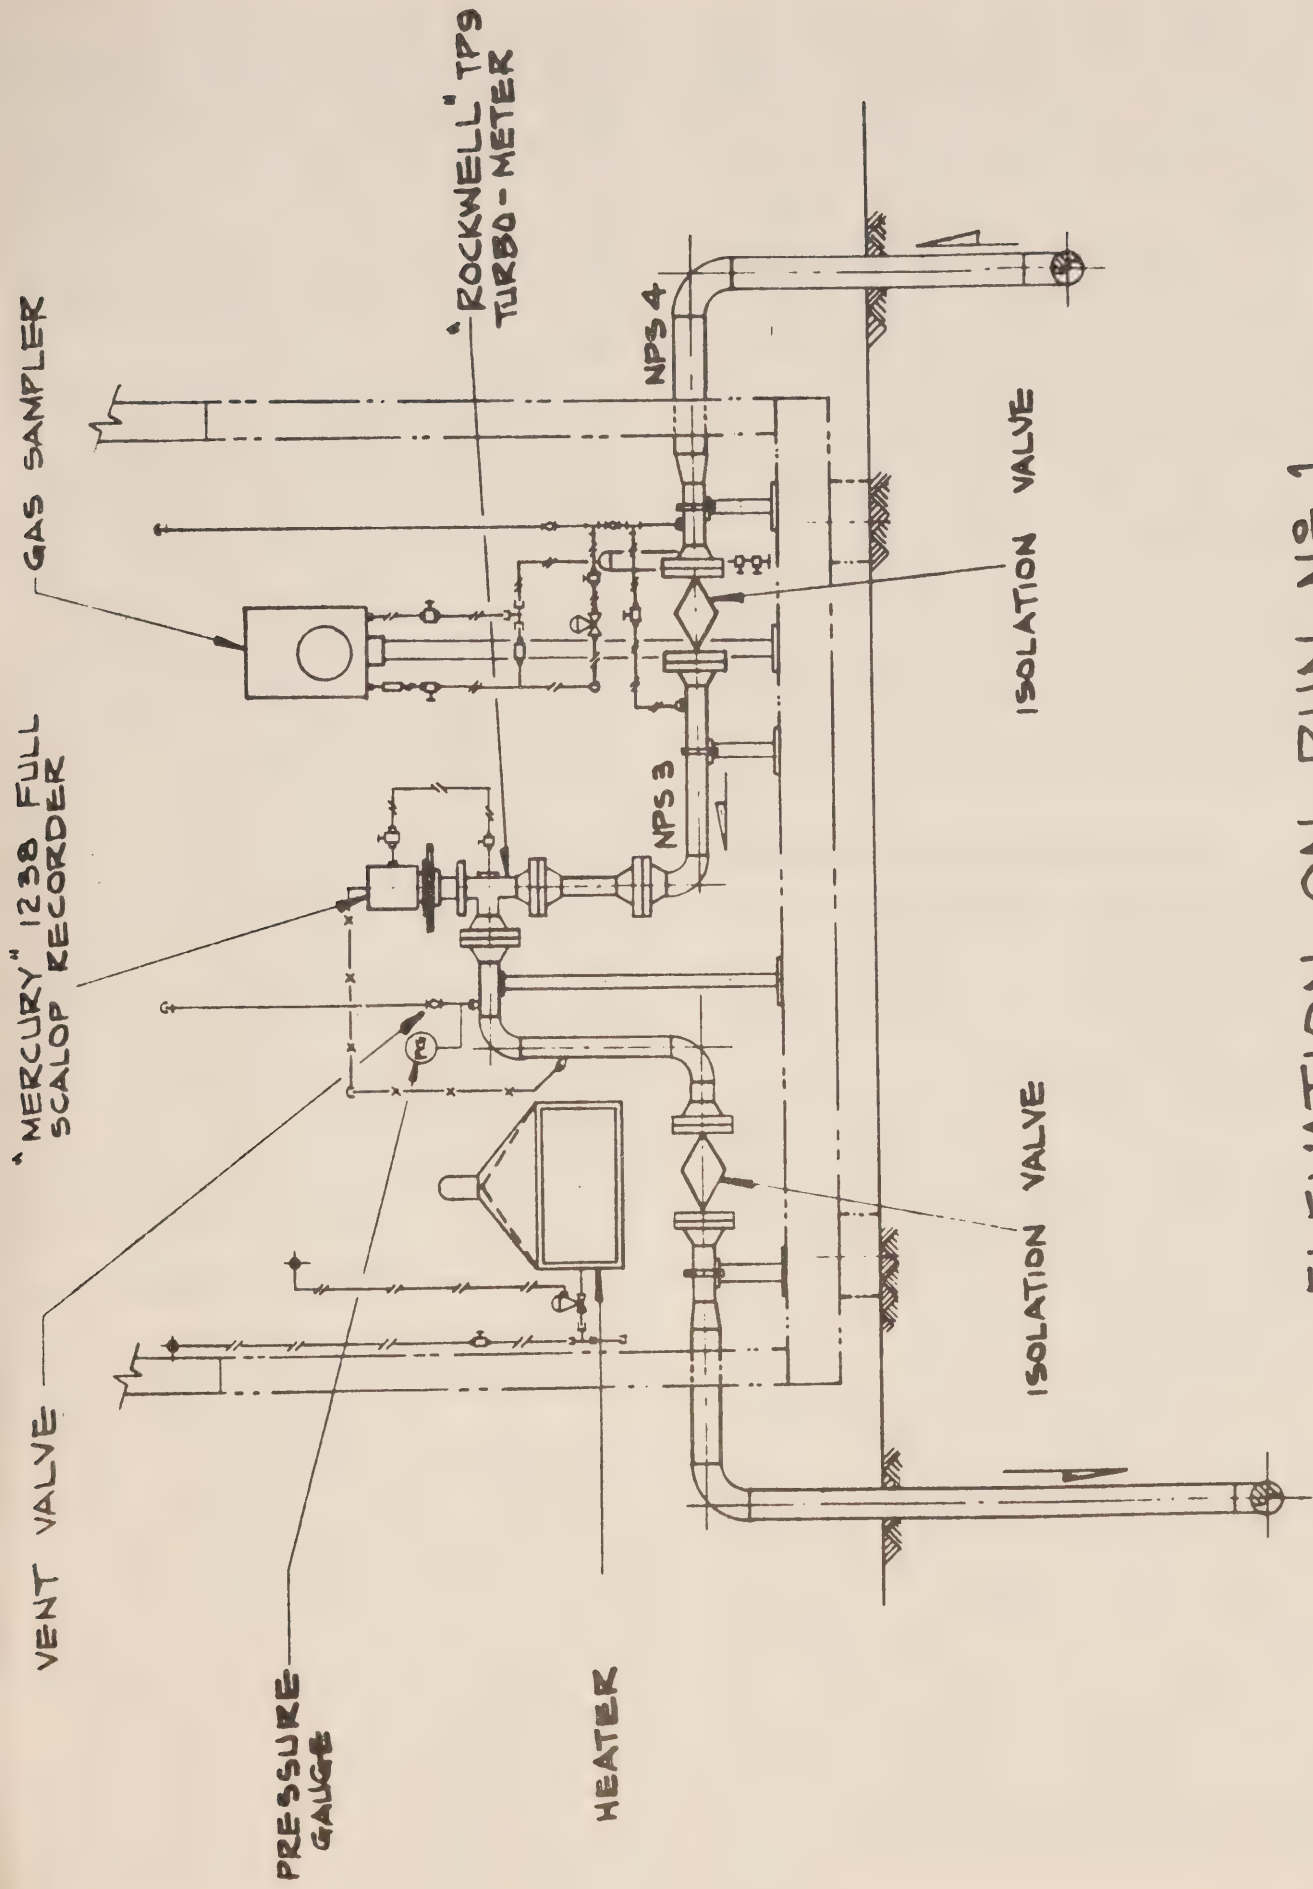
ELEVATION ON RUN N° 1

Figure 1 presents a schematic diagram of meter run #1 at the Liebenthal PMS facilities.

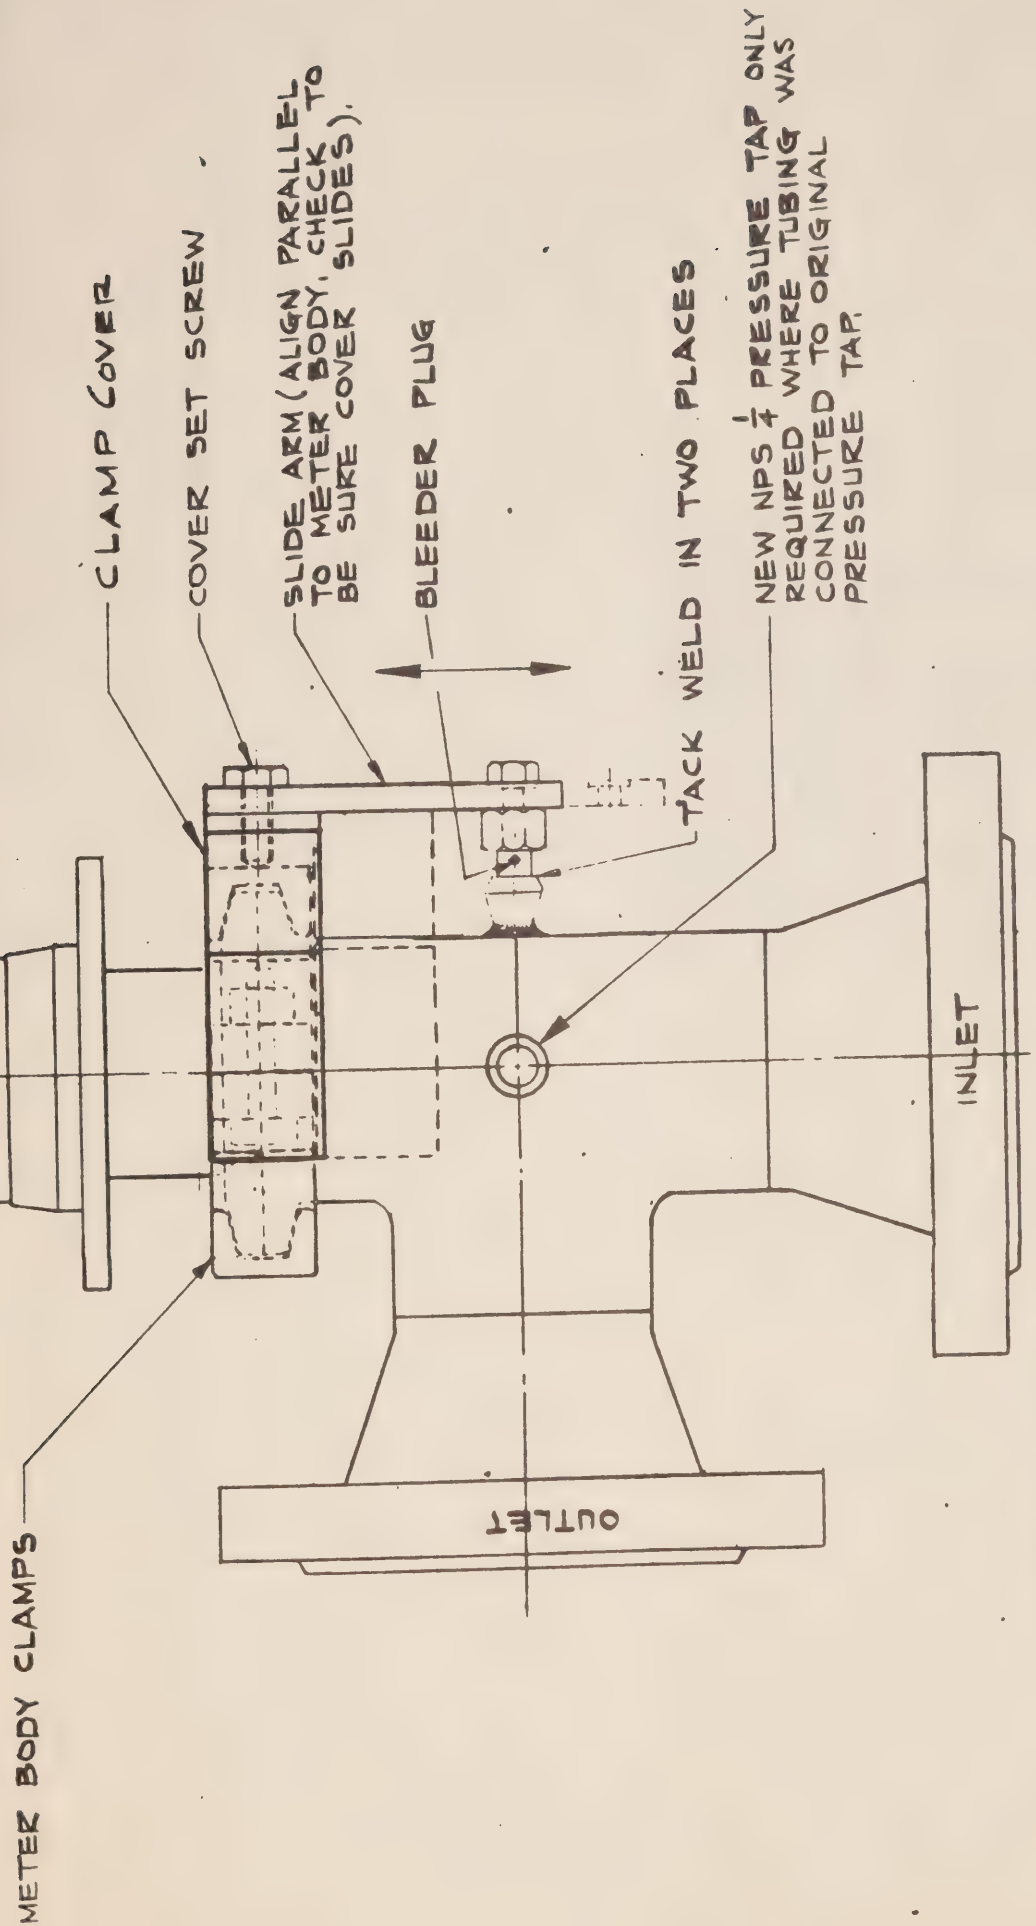
FIGURE 2

While the half clamp retaining flange on the TP-9 measuring module facilitates ease of maintenance in that it provides a simple and quick procedure to remove the closure device, it does not offer a positive means to prevent human error. Subsequent to the

accident, TransCanada PipeLines devised a clamp cover guard that will provide the employee with a warning that the line is loaded before he can remove the half clamps. The clamp cover guard fits over the half clamps making removal of the clamps impossible while the guard is in place. To lower the cover guard, the employee must undo a Plico plug with a wrench. At this time, if the line were still under pressure, the employee would hear the noise of gas escaping through a hole in the Plico valve. When the plug is fully removed, the guard lowers enough to expose the half clamps for removal. The clamp cover guard is permanently fixed to the meter. Figure 2 illustrates the side view of this safety cover installation.

- 8.4 Although the TP-9 turbine module retaining clamp accommodates ease of maintenance, it does not offer means to account for human error. A modification to provide for a physical interlock system should be pursued by Engineering, the Field Transmission group and the Vendor of the TP-9 and fitted immediately.
